**GEOLOGIC EVALUATION OF THE PROPOSED NEW TOWN SITE  
VALMEYER, ILLINOIS**

**Compiled by  
Anne L. Erdmann and Robert A. Bauer**

**Illinois State Geological Survey  
Open File Series 1993-12**

**December 30, 1993**

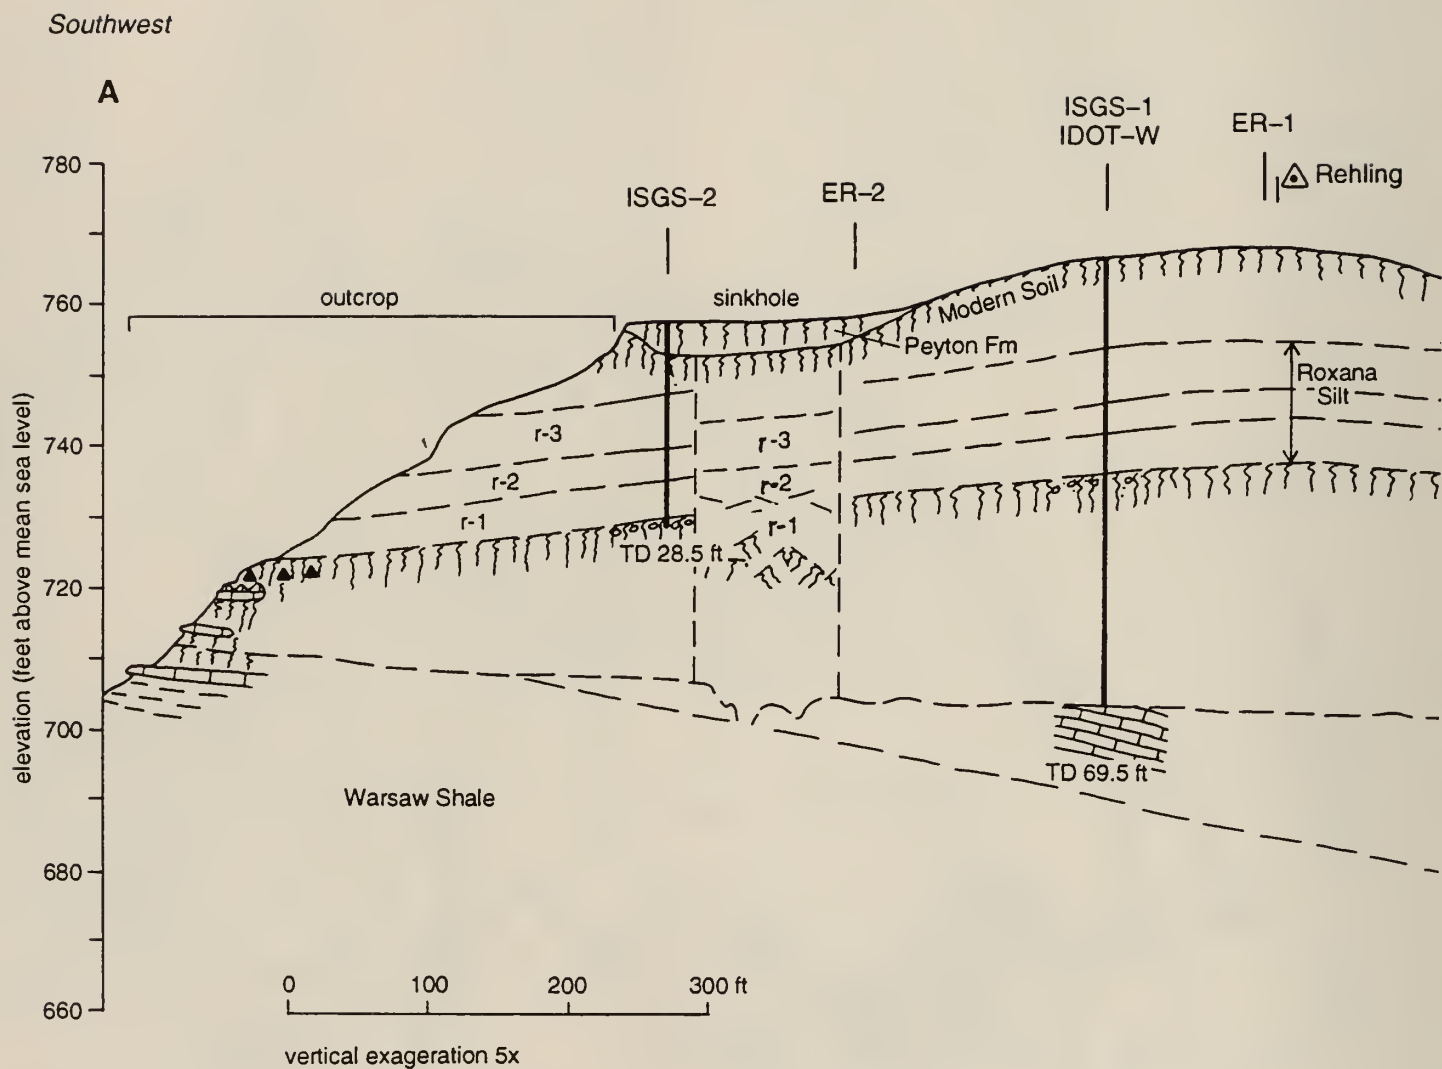
The thickness of surficial deposits, where measured by boreholes and earth resistivity, is shown on Figure 3. Beneath the highest parts of the landscape on drainage divides, the surficial deposits are typically greater than 50 feet thick. A maximum thickness of 75 feet was measured on the site. The surficial deposits are thin on steep slopes, and near the base of slopes, the deposits consist of a thin mantle of silt and limestone cobbles. In many of the deep gullies bordering the town site, bedrock units are exposed and have no surficial deposit cover.

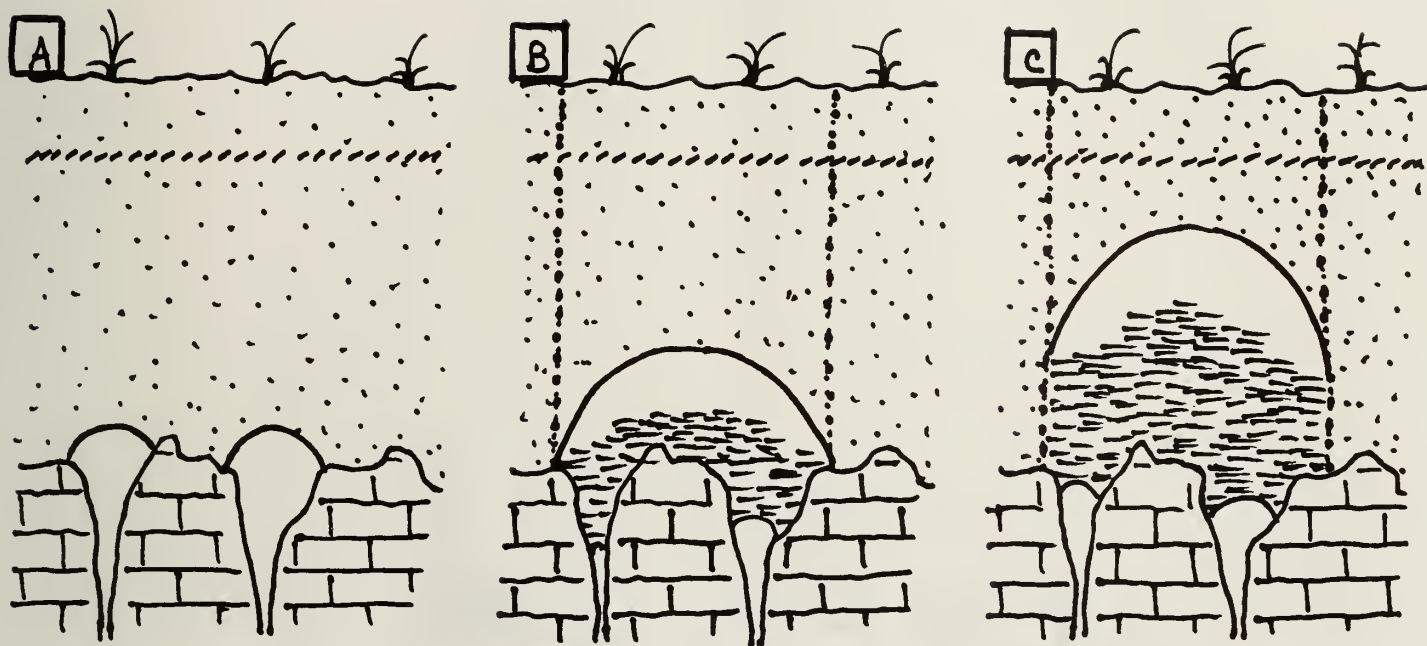
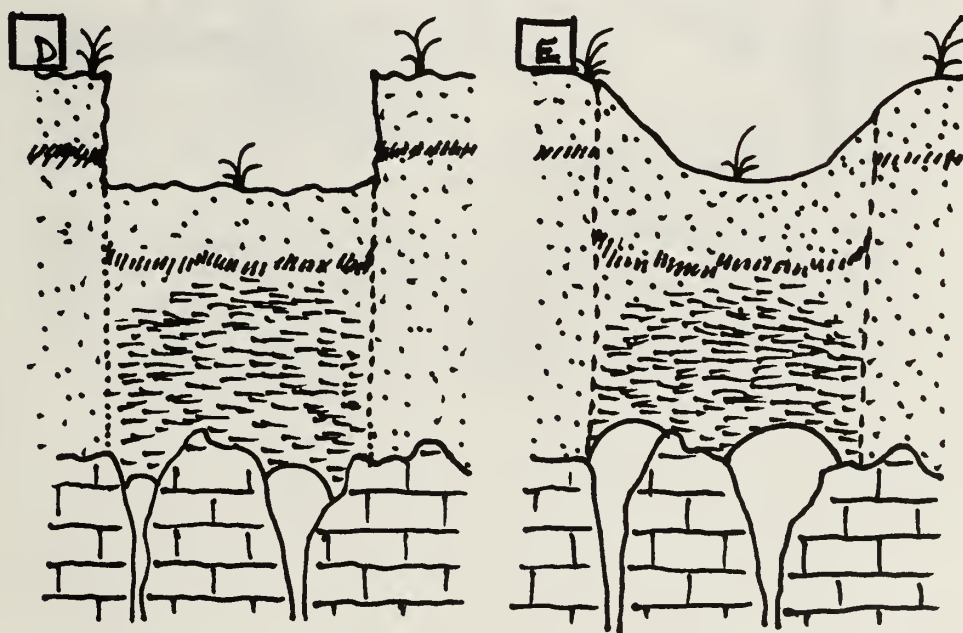
Dissolution of these rocks takes thousands of years and, in itself, is not a problem where the results are obvious. The problems arise when the dissolution feature is covered with tens of feet of loess or other material that bridge the enlarged feature. In these cases, the danger is hidden. Sinkholes form in loess in several ways. Collapse sinkholes are initiated as loess overlying a solution-widened bedrock fracture is washed downward into the fracture, forming a hollow soil dome above the fracture. Surface water draining into the soil along discrete pathways (soil piping) may remove small amounts of soil that make up the dome. Additional collapse may occur resulting in the enlargement of the soil dome (Figure 5). New sinkholes may have steep walls that extend from the surface to bedrock. At these thick loess sites, erosion of the steep walls of the hole occurs, rapidly forming a smoothed depression. Coalescing of two or more sinkholes will result in the formation of a compound sinkhole (Figure 6), such as the one seen in the northern arm of the site.

Figure 5. Formation of a collapse sinkhole in materials overlying karst limestone. A = Initial conditions of the undisturbed sediment over limestone. Hachured horizontal line represents paleosol (marker horizon). B = Collapse of materials into karstified limestone and the formation of a soil dome. Collapse is initiated by water infiltration and washing of sediment into solution-enlarged crevices. Vertical dotted lines represent planes of weakness caused by soil dome formation. C = Continued collapse of materials and upward movement of soil dome. D = Collapse of surface materials into soil dome. E = Smoothing of sinkhole by collapse and erosion of steep walls of sinkhole and accumulation of sediment.

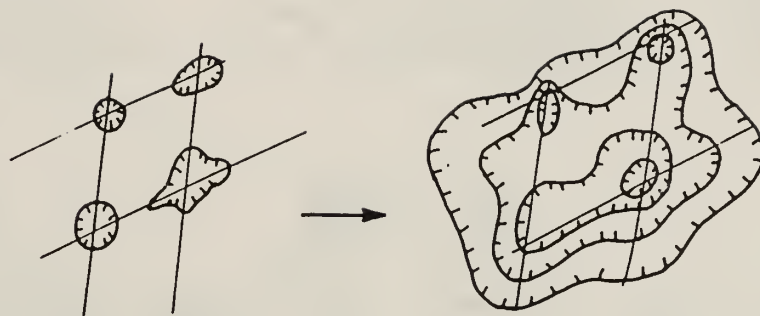
Figure 6. Evolution of a "compound sink". Individual sinkholes enlarge and coalesce forming a larger closed depression with several nested sinkholes that are points of infiltration (from White, 1988).

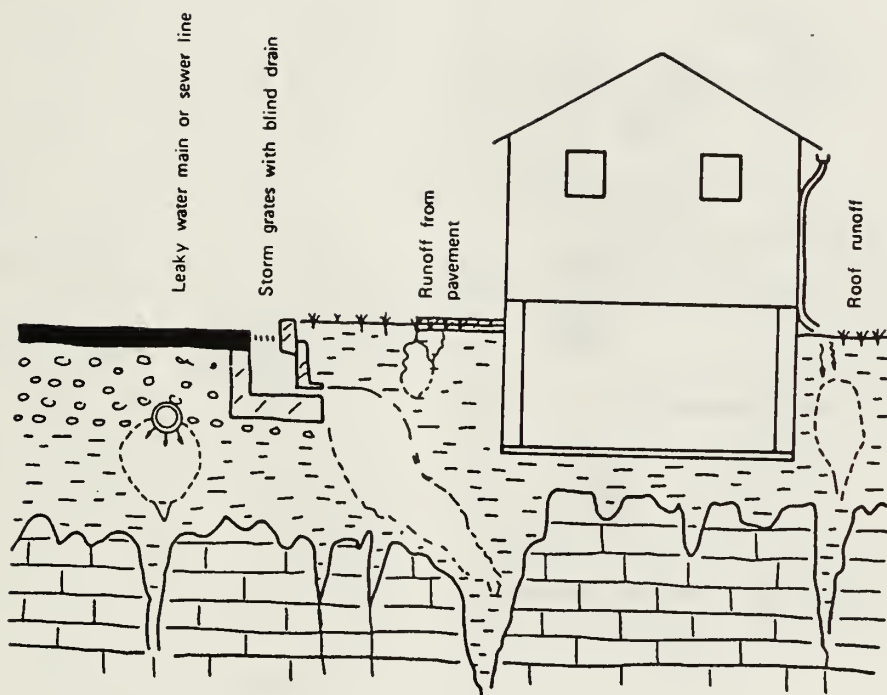
Human activities can accelerate the sinkhole formation process by increasing and concentrating recharge of water to the loess and silt overlying karst bedrock. An increase in the movement of water through the soil can upset the delicate balance of soil materials overlying cavities and crevices. Roads, driveways, roofs, storm drains, retention ponds, and broken or leaking water or sewer pipes all can concentrate water runoff that can lead to the subsurface erosion of materials filling cavities in the limestones, subsurface piping, and cover collapse (Figure 7).

Figure 7. Soil piping that can result from modification of surface topography and drainage, leaking water lines, and improper disposal of storm runoff (from White, 1988).
